# **FINAL REPORT TO CONGRESS**

**THE STREAMBANK EROSION CONTROL  
EVALUATION AND DEMONSTRATION ACT OF 1974  
SECTION 32, PUBLIC LAW 93-251**

## **MAIN REPORT**

**U.S. ARMY CORPS OF ENGINEERS  
December 1981**

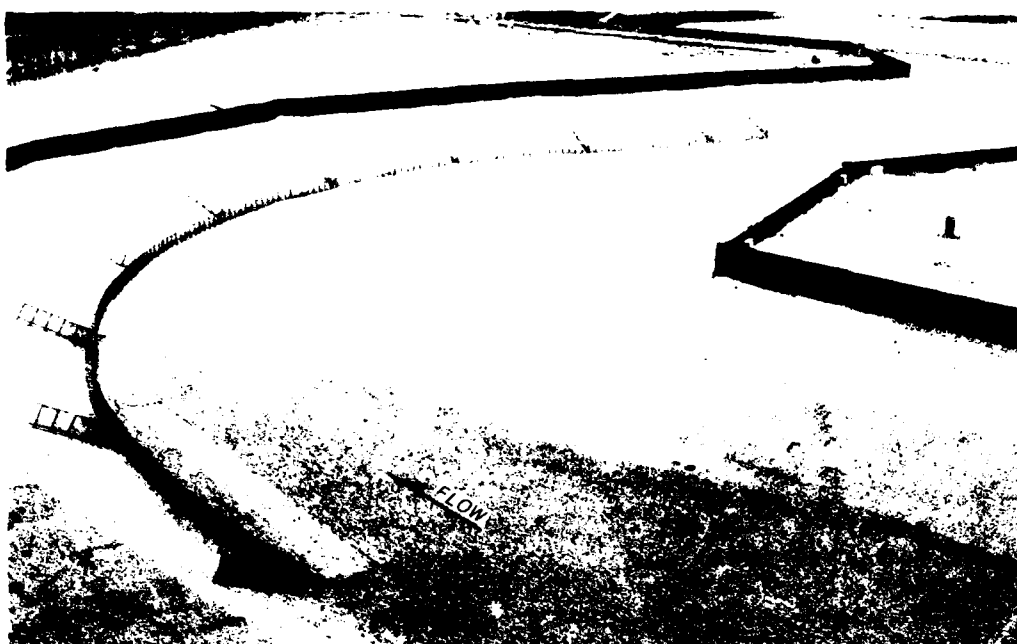
Exhibit VI-4. Laboratory model of single-row wire fence retard (before testing) in loose sand model channel

**Fencing** can be used as a low-cost bank protection technique on small to medium size streams. Special structural design considerations are required in areas subject to ice and floating debris. Both longitudinal (parallel to stream) fence retards and transverse (perpendicular to stream) fences have been used in the prototype with varying degrees of success. A model investigation (Exhibit VI-4) and literature review of longitudinal fence retards with tiebacks were conducted to identify the following important design considerations:

- (a) Channel gradient must be stable and not be steep (tranquil flow).
- (b) Toe scour protection can be provided by extending the support posts well below the maximum scour expected or by placing loose rock at the base of the fence to launch downward if scour occurs at the toe.
- (c) Tiebacks to the bank are important to prevent flanking of the fence and to promote deposition behind the fence.
- (d) Fence retards generally reduce attack on the bank so that vegetation can establish.
- (e) Metal or concrete fences are preferred due to ice damage and fire loss of wooden fences.

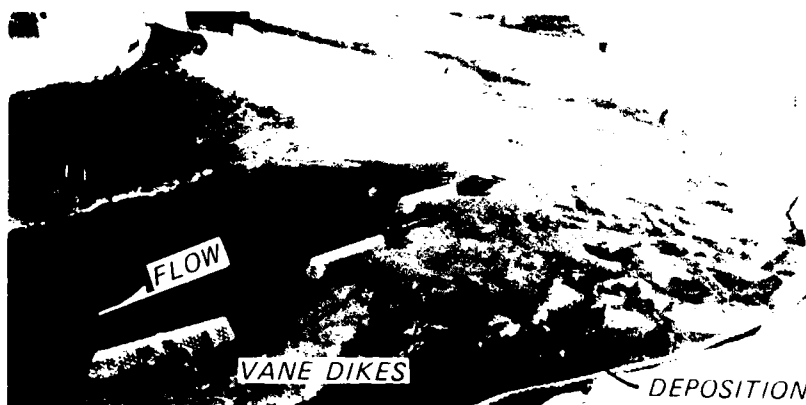
Exhibit VI-7. Vane dike model, ground walnut shell bed, during low stage portion of test run elevation 1.482 ft (Mead Laboratory)

**Vane dikes** are low-elevation structures designed to guide the flow away from an eroding bank line (Exhibit VI-7). The structures can be constructed of rock or other erosion-resistant material, the tops of which are constructed below the normal water surface and would not connect to the high bank. Water would be free to pass over or around the structure with the main thread of flow directed away from the eroding bank. The structures will discourage high erosive velocities next to an unprotected bank line, encourage diversity of various channel depths, and protect existing natural bottomland characteristics. The findings from the model investigation of these structures include the effects of various vane dike orientation, vane dike length, and gap length.

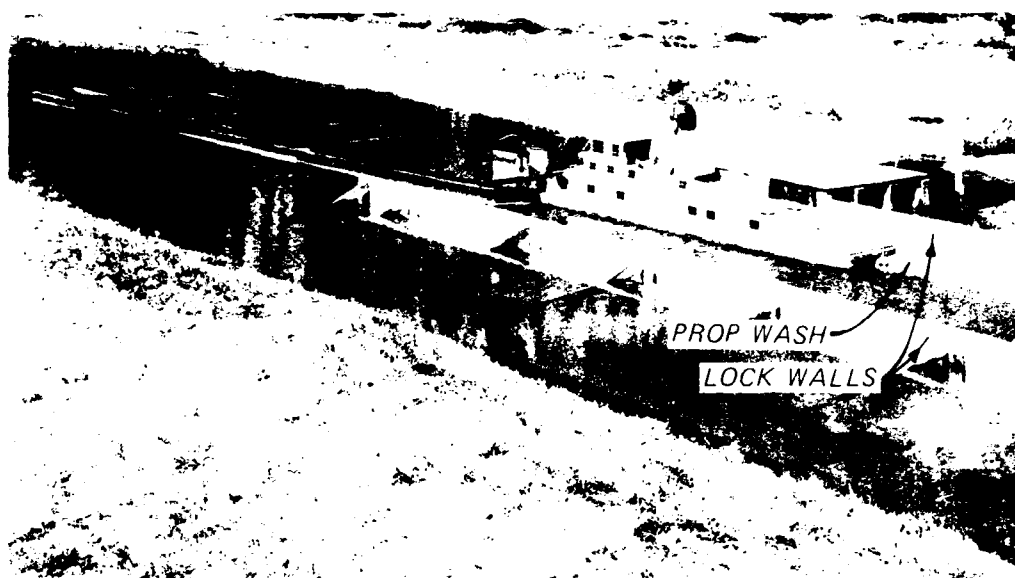
*Exhibit VI-10. Shallow-draft inland navigation model, fixed banks, with tow for study of riprap size required on channel bottom in maneuvering areas (WES Laboratory)*

Streambed stability in and around navigation locks and dams and berthing areas has become of concern on the Nation's waterways due to the large horsepower vessels in operation today. A 1:20-scale model (Exhibit VI-10) typical of shallow-draft inland navigation tows was used to determine the conditions required for stable riprap protection of the streambed as a function of depth and towboat size. Relations between stable rock size, depth, and size of towboat with two propellers were determined and found to be in fair agreement with results of a design technique for a single-propeller tow found in the engineering literature.

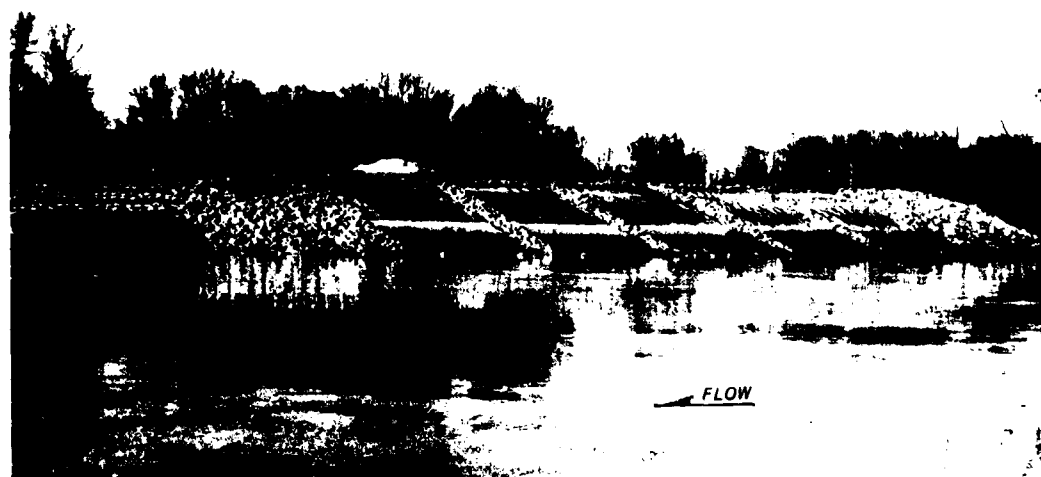
*Exhibit VI-18. Test materials installed at Big Black test site*

The test area was reshaped to a more uniform and slightly flatter slope for installation of test materials. Test items illustrated in Exhibit VI-18 were constructed approximately 22 ft wide (parallel with water flow) and 42 ft long (perpendicular to water flow) of the following materials: riprap placed

on filter fabric; blankets of Hypalon, laminated vinyl, and neoprene-coated membranes; MESL constructed with laminated vinyl-coated nylon; riprap placed on filter fabric (standard comparison item); and stair-stepped MESL constructed with laminated vinyl-coated membrane.

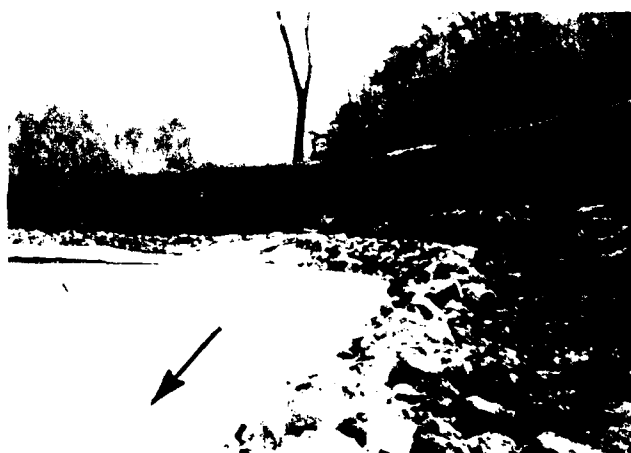
April 1978  
before construction

April 1979,  
as constructed

May 1981, two years  
after construction

Exhibit XI-2. Peaked stone dike, Johnson Creek

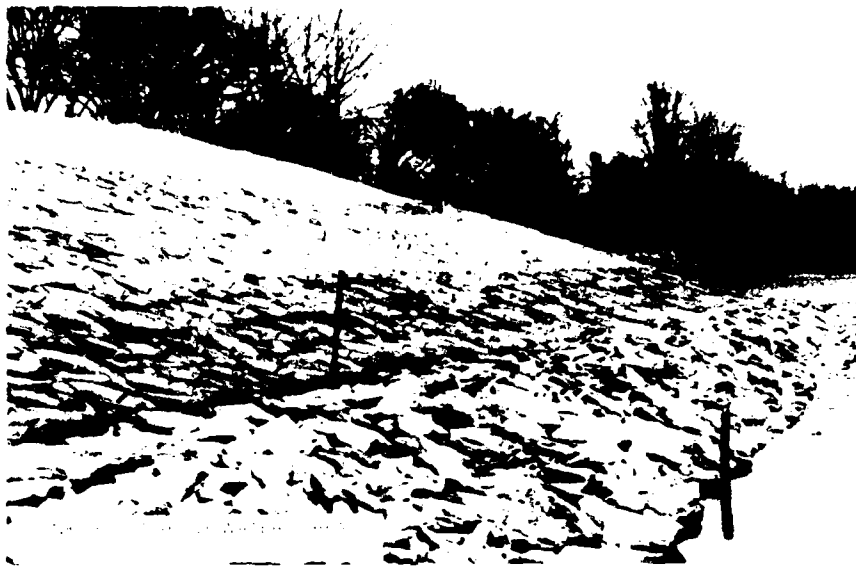
Exhibit XII-5. Tire mattress with rock toe, Roanoke (Staunton) River, Virginia

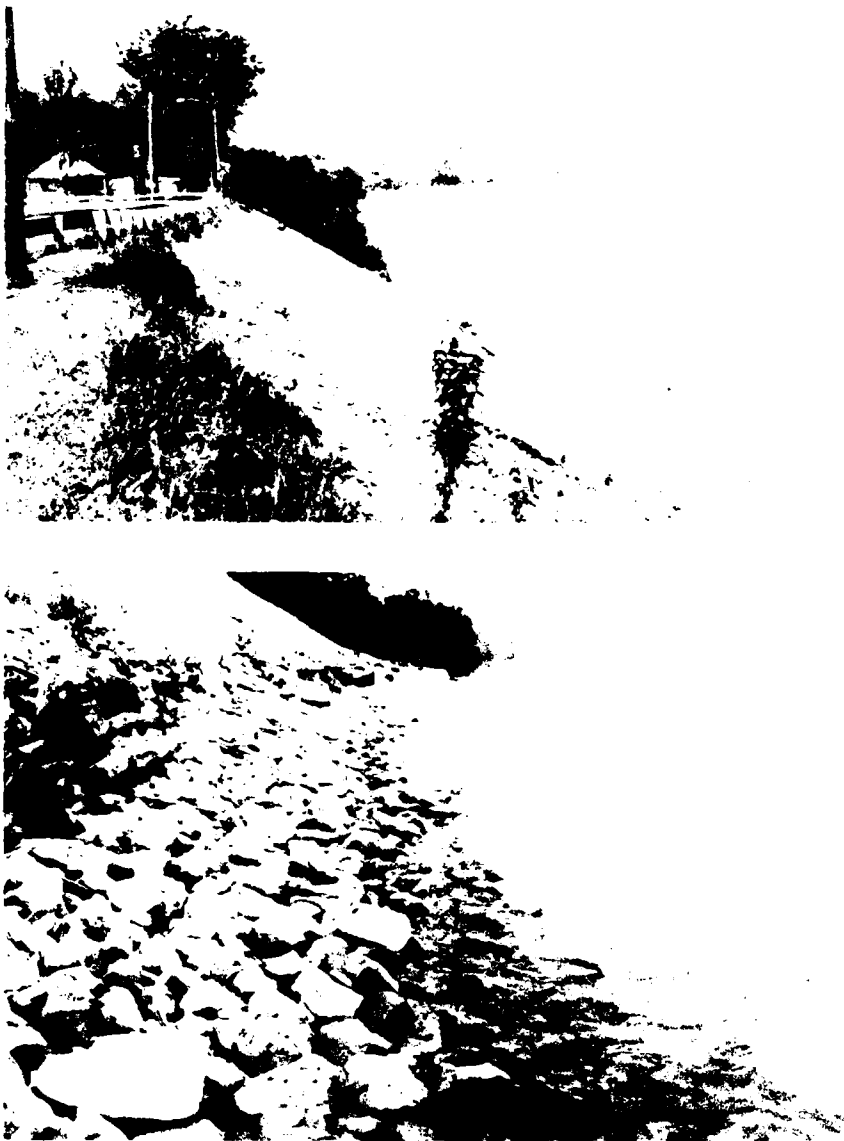
*Exhibit XIII-4. Ohio River (left bank) at Cloverport, Kentucky. Downstream view shows toe of revetment under wave attack due to passing barge traffic (19 June 1978). Typical riprap revetment constructed by the Corps of Engineers (successful)*
